New Hampshire Volunteer Lake Assessment Program

2003 Interim Report for Forest Lake Winchester

NHDES
Water Division
Watershed Management Bureau
29 Hazen Drive
Concord, NH 03301

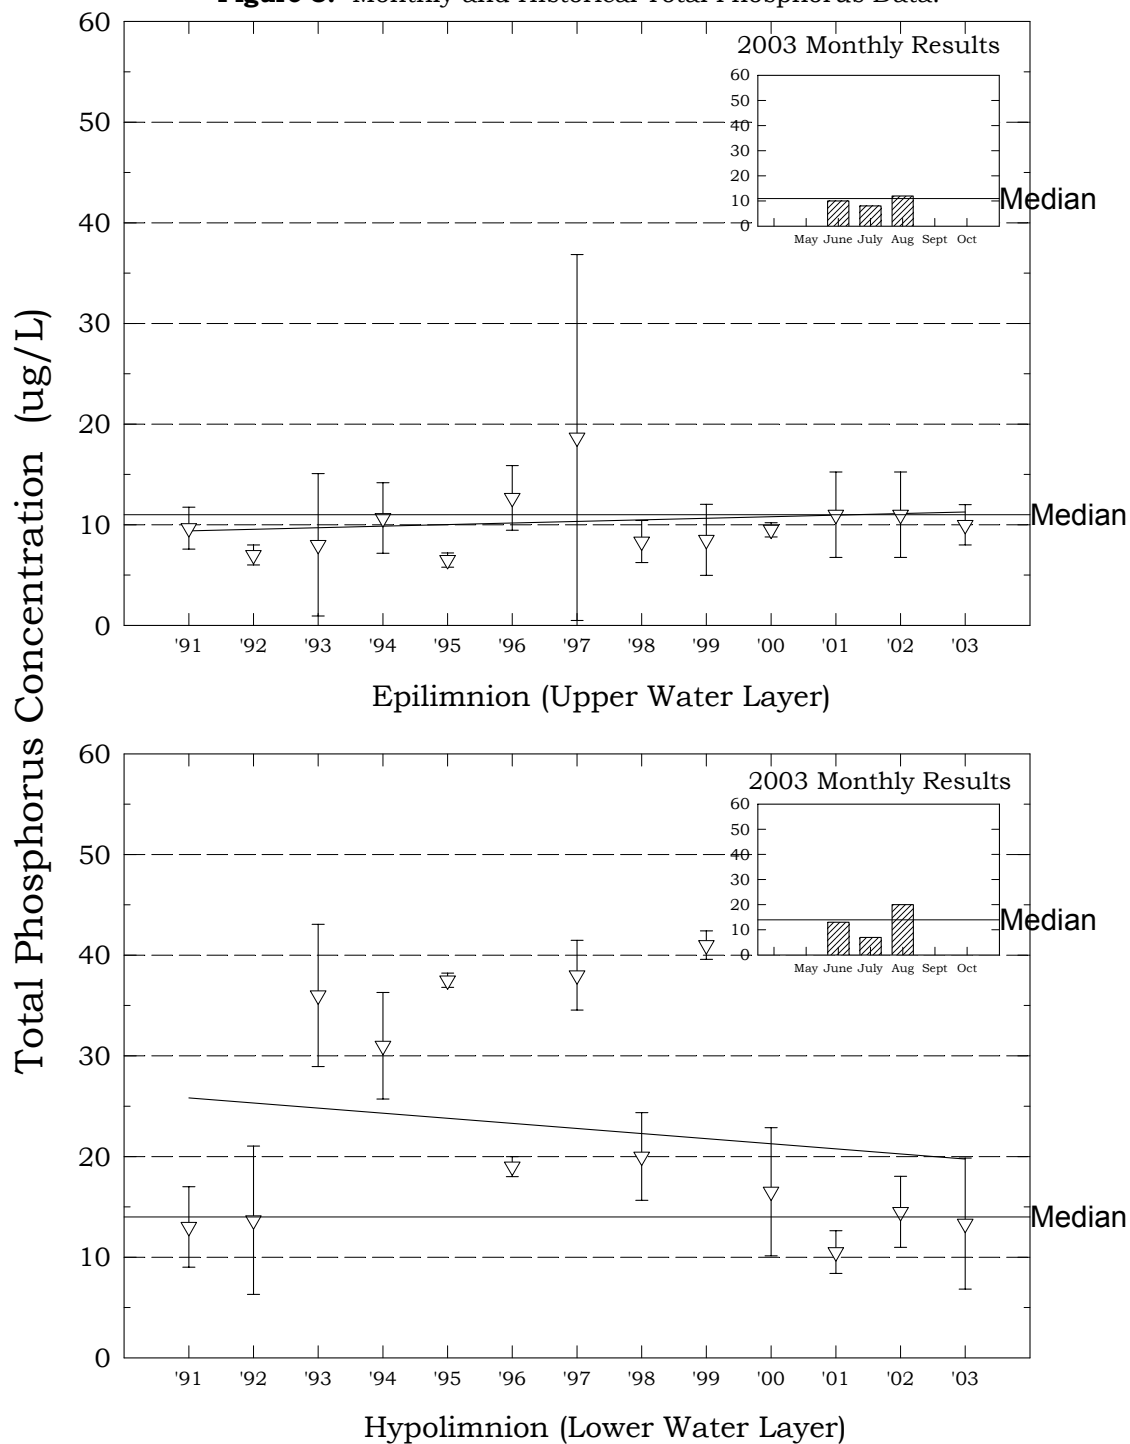
Figure 3. Monthly and Historical Total Phosphorus Data.

- **Figure 3 and Table 8:** The graphs in Figure 3 (Appendix A) show the amounts of phosphorus in the epilimnion (the upper layer) and the hypolimnion (the lower layer); the inset graphs show current year data. Table 8 (Appendix B) lists the annual maximum, minimum, and median concentration for each deep spot layer and each tributary since the lake/pond has joined the program.

The current year data for the epilimnion (the top inset graph) and the hypolimnion (the bottom inset graph) show that the phosphorus concentration **decreased** from June to July, and then **increased** from July to August. The phosphorus concentration in June was **slightly less than** the state median, in July was **less than** the state median, and in August was **greater than** the state median.

The historical data show that the 2003 mean epilimnetic and hypolimnetic phosphorus concentrations are **approximately equal to** the respective state medians.

Overall, visual inspection of the historical data trend line for the epilimnion and the hypolimnion shows a **variable** phosphorus trend. This means that the phosphorus concentration in the epilimnion and in the hypolimnion has **fluctuated**, but has not *continually increased* or *continually decreased* since monitoring began.

One of the most important approaches to reducing phosphorus loading to a waterbody is to continually educate watershed residents about its sources and how excessive amounts can adversely impact the ecology and value of lakes and ponds. Phosphorus sources within a lake or pond's watershed typically include septic systems, animal waste, lawn fertilizer, road and construction erosion, and natural wetlands.
